## **MANGO PRODUCTION AND FRUIT QUALITY UNDER PROPERLY MANAGED DRIP IRRIGATION SYSTEM**

### **ABSTRACT**

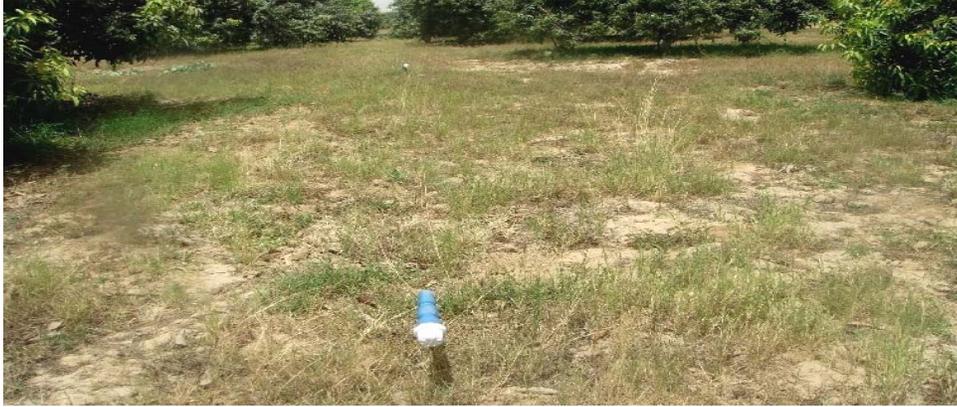
Plate 1. View of drip irrigated mango orchard

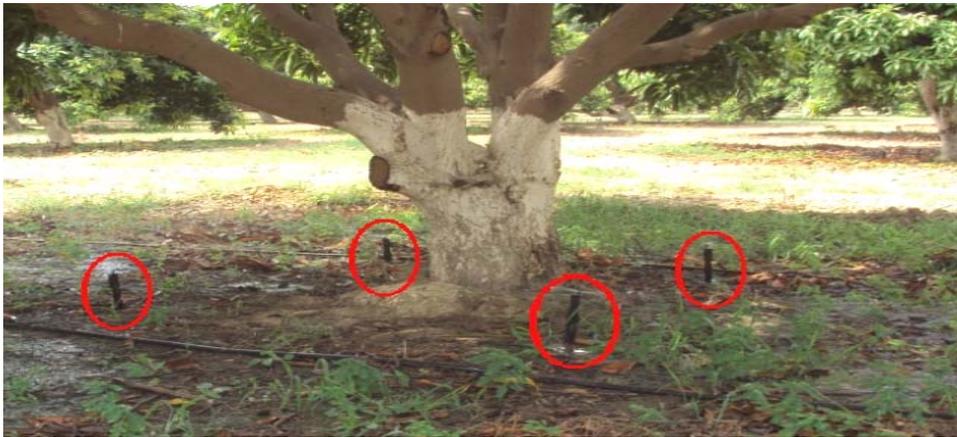
Plate 2. A mango plant with four drippers

On the average, a tree had canopy radius between 2.8 to 3.2 m. Each mango tree an irrigated by four drippers (work as low pressure jet sprinklers). They were installed at a distance of about 0.5 to 0.6 m from the trunk/stem. Significant moisture was observed within a one meter radius, while beyond this, the moisture reduced towards the outer sides of the tree canopy. The number of drippers was not enough to provide adequate water to meet water requirements of tree. It was further observed that the orientation of the drippers was inappropriate as a consequence outer edges of the canopy of tree/plant

remained under irrigated. This caused dry stress in the plant roots located in that vicinity, which could be avoided by increasing the number of drippers and through their proper placement around the canopy. The lateral pipes should run along the circumference around the canopy. If required, the system should be operated for longer periods so that water could reach the dry areas around the canopy.

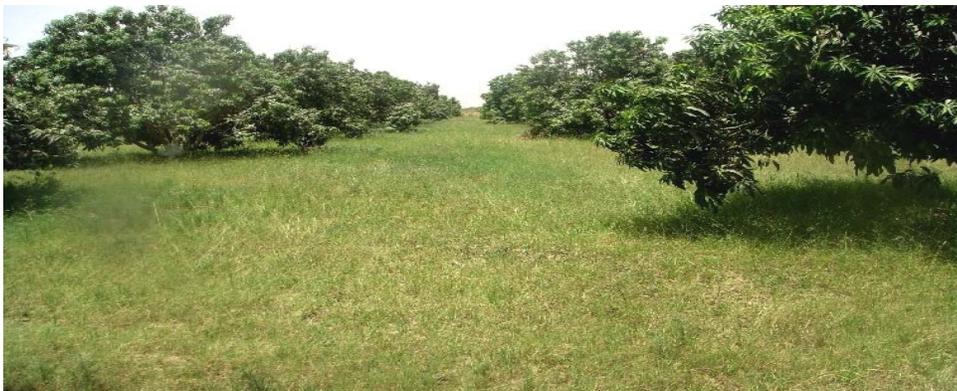
Plate 3. View of mango orchard irrigated with basin irrigation

The continuous dripping in the surrounding of the main trunk causes excessive wetting that may result in a problem of root rot/wilt in long run. This may also result in root death that ultimately will affect fruit quality and reduce the yield. It may also be recalled that the drippers are installed near the main trunk at a distance of about 45 to 60 cm from the stem only which cause such wet stresses (plate 3). While designing a system, a due consideration needs to given to the placement of the drippers.

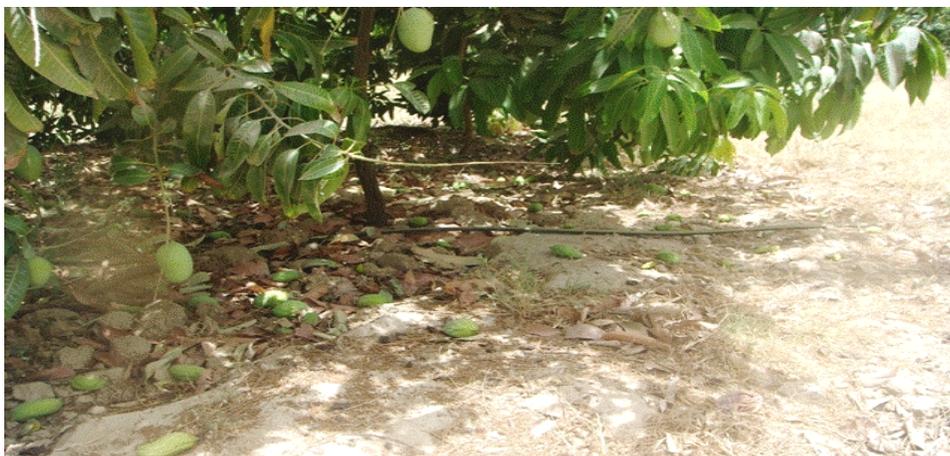
Plate 4. Fruit drop from drip irrigated mango tree

Under normal moisture conditions, the fruit set in mango remains unaffected; however, the prolonged soil moisture deficit has the serious consequences. The soil moisture deficiency reduces the fruit size and its quality and increases the drop of immature mango fruit. During fruit development period, under hot and dry climate, the irrigation prevents the drop of immature fruits. Early maturity of fruits was observed under drip irrigated trees that could be attributed to dry stresses under drip irrigation method. The drop rate was higher under drip irrigated trees than basin flooded ones (plate 4). The dropped immature mangoes were collected under drip and basin irrigated trees. The total number and weights were recorded. The results suggest that the drop rate was higher by about 25% under drip irrigated trees as compared to basin flooded ones. The mangoes dropped under drip irrigated trees have less weight as compared to basin flooded dropouts. The fruit quality and mango yield under drip irrigated mangoes was slightly affected. While the basin flooded mangoes has higher weight with a fresh appearance. It was further observed that the basin irrigation provided sufficient moisture to the plants during fruit development and maturity period hence the fruit quality was better than the drip irrigated mango trees. The better sized mango fruit with a juicier flavor was observed under basin irrigated tree's than those from tree under deficit soil moisture under drip irrigation.

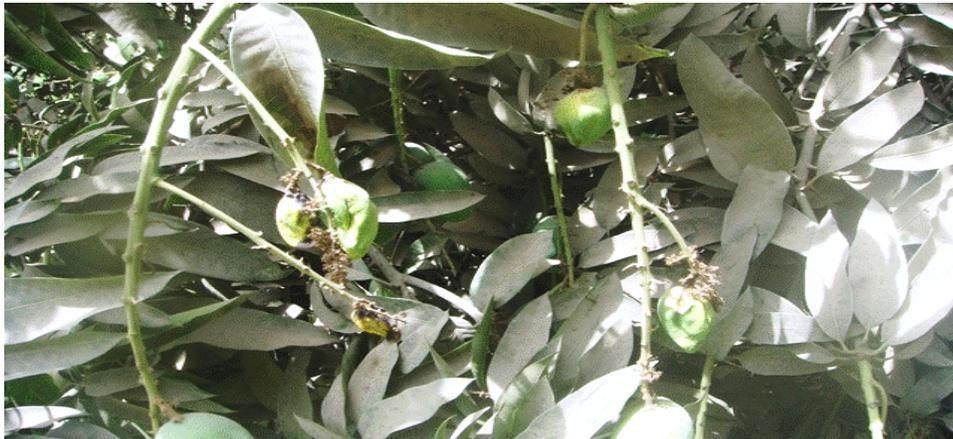
Plate 5. Showing branches with suffering fruit

No serious problem of any insect pest or disease was observed in the mangoes. Rarely mango midge and scale insect infestation were noticed. Few leaves were found infected with tips die back and bacterial leaf spot diseases (plate 5). Such symptoms may be attributed to inadequate water and nutrition deficiency.
